Background, Long Term Issues & Trends

Grasmere Lake

Updated **October 2014**; questions to: alan.polonsky@denvergov.org

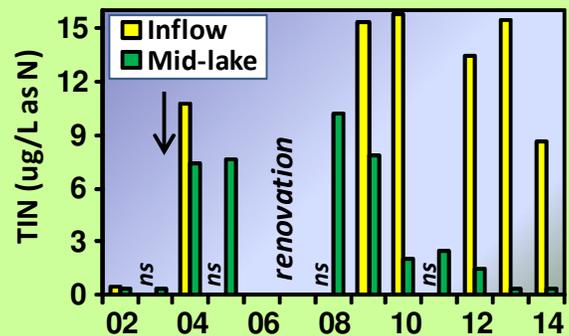
Total inorganic nitrogen* in Grasmere Lake inflow (City Ditch) and at mid-lake (2002 – 2014). Arrow indicates switch to re-use water in ditch (*ns* = no inflow sample).

*Total inorganic nitrogen includes ammonia, nitrite, and nitrate fractions of nitrogen.

- Wastewater treatment plant improvements have resulted in significantly lower nitrogen concentrations in the lake's source water (see figure below). This will benefit the condition of Grasmere and the other lakes that rely on re-use water.

- Monitoring data suggests that since 2010, much of the nitrogen is assimilated in lake components other than water (i.e., vegetation and sediment; see figure below).
